## Airbus A330 - Qantas Flight QF72

### Background Facts and Potential Cause Analysis

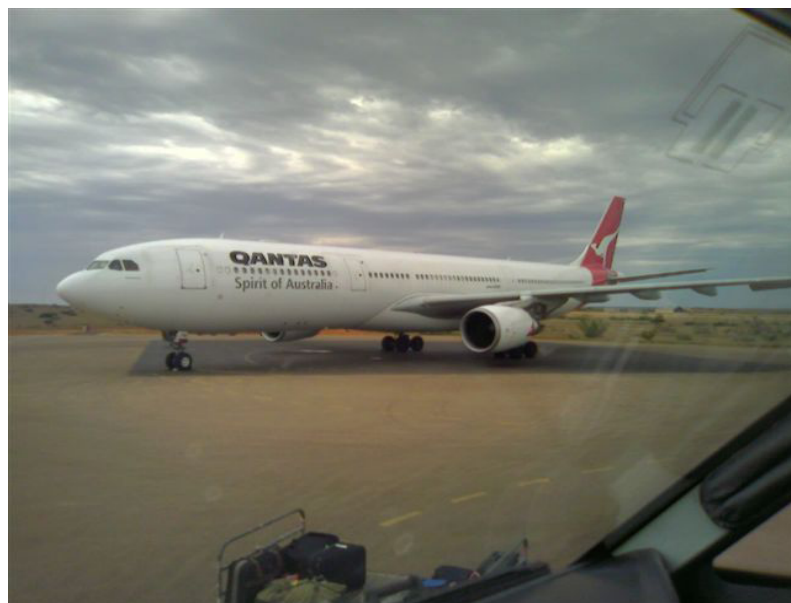
VH-QPA parked at Learmouth

Damage to the aircraft was sustained mainly to the personal service units located above passenger seats and ceiling panels. There was evidence of impact damages in these areas and nine oxygen masks had deployed.

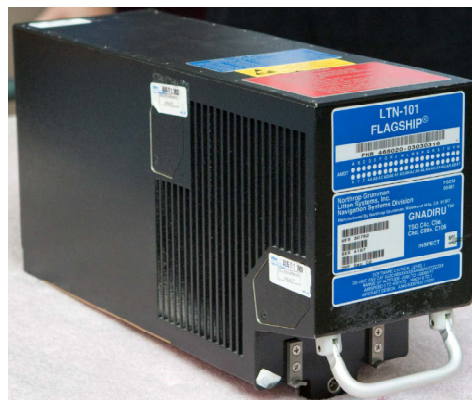
The ADIRU

The ATSB's investigations so far have revealed that one of the Air Data Inertial Reference Units (ADIRU1) was providing erroneous data, or 'spikes', to the other aircraft systems. The job of the ADIRUs (there were three on this particular aircraft) is to supply data such as altitude, speed, angle of attack, temperature, position and track to the aircraft's flight control computers so they can make the relevant adjustments to the flight controls.

As a result of these 'spikes', the crew received numerous fault, caution and warning messages including an aural stall warning and fluctuating airspeed and altitude indications. It is also likely that the spikes recorded by the ADIRU led to the involuntary disconnection of the autopilot, which occurred at 12:40pm, just before the first in-flight event. Details recorded on the aircraft's flight data recorders indicate that the 'spikes' continued throughout the rest of the flight, until the aircraft landed in Learmouth.

In most cases, erroneous data provided by ADIRUs is filtered by the flight control primary computer (or PRIM) and does not affect the flight control commands. In this case however two spikes which came from the Angle of Attack (AOA) sensors were not filtered and the aircraft sought to correct itself from the position it thought it was in by pitching down. No faults were found with the AOA sensors themselves and the likelihood of erroneous AOA inputs having an influence on flight control commands is extremely rare. The ATSB investigation identified a very specific situation when the pitch down command would be generated and unfortunately this occurred twice in the space of a few minutes during this flight.

The ATSB are continuing their investigations because they have not identified what caused the ADIRU to malfunction. The ADIRU1 unit is currently in the possession of the manufacturer, Northrop Grumman, in Los Angeles, locked in a secure storage room, awaiting the arrival of the ATSB investigation team. One possible explanation for the 'spikes' is Electromagnetic Interference (EMI).
